## HSEM ALERT

### B201 Electrical Safety Incident

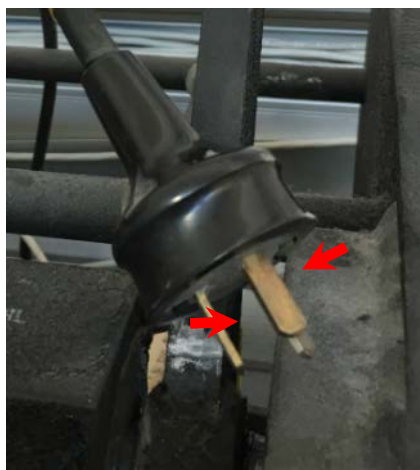
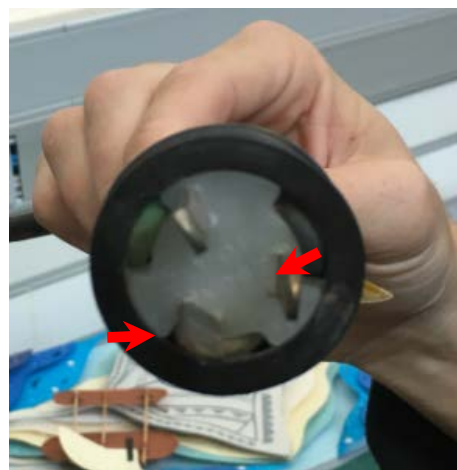
Whilst installing a new data cable, the cabling duct lid made contact with the uninsulated pins of an appliance plug, which was incorrectly inserted into the socket outlet. This caused the duct lid to become live and the individual to receive an electric shock.

Root Cause: Uninsulated pins of appliance plug

Contributing Factors: Old style of plug. Plug did not meet current Australian Standards

**Fig.1 & 2 Uninsulated Pins of old style plug**

- Complete an audit of electrical equipment in your work area to identify old style plugs.
- Licenced electrician to replace old style plugs with Australian Standard compliant plugs.

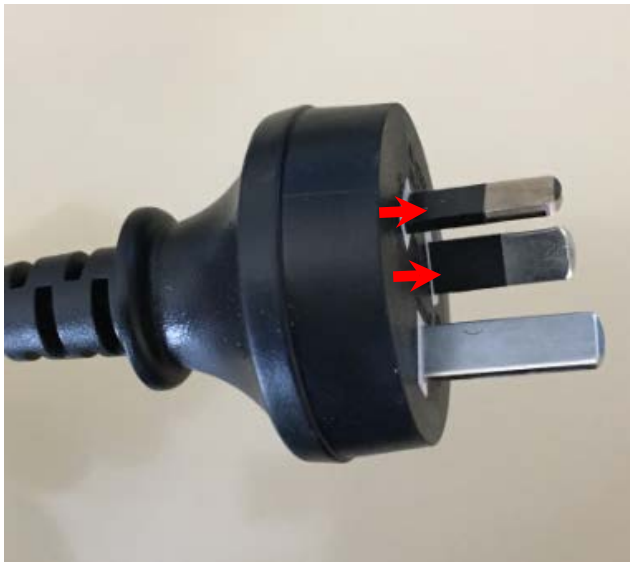
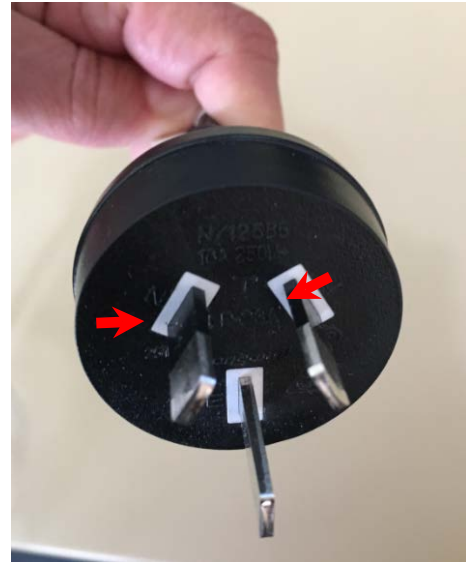
Fig. 3 & 4 Insulated Pins – current Australian Standards
