SAFETY ALERT

Electrical Shock Incident

Date of Issue 17/03/2015

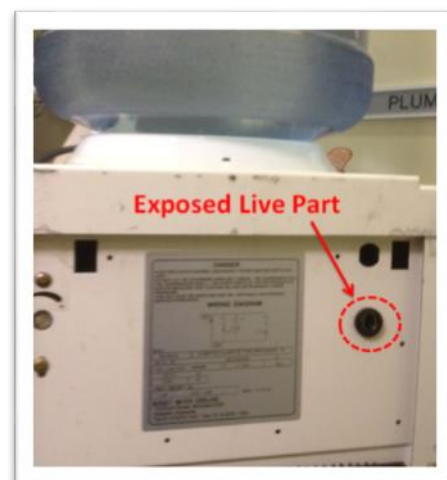
Upon moving a water cooler to locate a switch behind the unit, a staff member received a minor electrical shock to his hand when he inadvertently touched a live component on the unit. The incident caused the RCD to trip protecting the individual. The staff member proceeded to follow the correct process by isolating and tagging the cooler out-of-service, seeking medical attention and reporting the incident.

Both Western Power and Curtin Electrical Engineering investigated and concluded that the electrical shock was caused by an incorrectly wired fuse and missing fuse cap. Western Power contacted the supplier Aussie Natural Spring Water who committed to check all units supplied to Curtin and implement a test and tag program.

If you have a cooler supplied by Aussie Natural Spring Water which does not display a current electrical inspection tag, please notify the supplier on 9308 9400 or 1300 360 332 to arrange an inspection.
