HSEM ALERT

Scissor Lift Incident

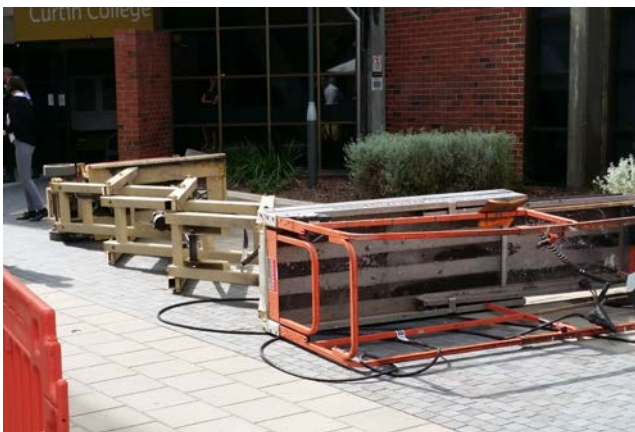
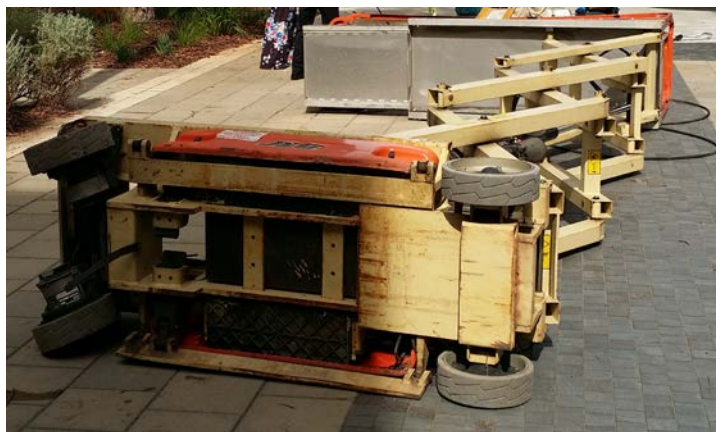
- The hose being used was at its maximum extension and bound around the cradle of the scissor lift.
- The hose being used by the contractor was not of adequate length for the job being undertaken.
- Approved Job Safety Analysis and Safe Work Method Statement were not complied with.
 - There was no spotter to monitor the activity and prevent over extension of the hose.
 - Contractor did not have suitable safety equipment, i.e.: barricading, which had to then be provided by Curtin.

- Ensure that a Job Safety Analysis, Safe Work Method Statement and Work Permits are completed, approved and kept on site at all times. Where these are not available on request, contractors will be asked to cease all activities immediately.

- Contractors to arrive on site prepared for the work and with suitable equipment and personnel to comply with Permit, Job Safety Analysis and Safe Work Method Statement requirements. Where this is not complied with, contractors will be asked to cease all activities immediately and leave site.

- Mobile and other equipment selection to be 'fit for purpose'. Where equipment is not deemed appropriate for the job, contractors will be asked to cease all activities immediately and leave site.

- Complete a site inspection & job task review to identify possible hazards and additional controls required, e.g. hose length, weak link clips, fall arrest equipment, mobile equipment weight rating for total load (includes personnel and tools).

- Conduct a visual inspection of all equipment to ensure they are in good working condition and fit for purpose.
- Check the working environment for hazards e.g. over-head power lines or other obstructions in the vicinity of work site. Work surface to be even, stable, and clear of debris, alternatively, use an all-terrain lift with extended outriggers to maintain stability during operations.

- Ensure adequate exclusion zones and barricading are set up around the work area to prevent access to the area and risk from falling objects eg: hand tools.

- Do not attach hoses, power leads, etc. to the cradle. Wherever possible, all equipment should be contained within the elevated work platform boundary. Where this is not possible, a spotter is to be provided.

- Lower the cradle prior to moving or exiting the scissor lifts.
- Workers to remain within the cradle and guardrails when working at heights. Ensure the load weight is evenly distributed on the platform.

- Ensure that cradle gates are closed and guard rails are secured in place.
- Load scissor lift for transport whilst still within the barricaded area.
