HSEM ALERT

Construction Site Cable Management

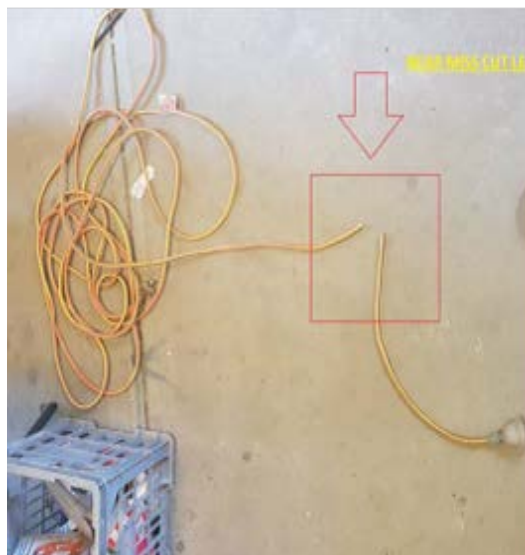
A demolition sub-contractor was breaking penetration blocks using an electric jackhammer when the electrical lead was caught between the jack hammer and block severing the lead. No injury was sustained by the sub-contractor.

1. Conduct a risk assessment to identify hazards and control risks.
2. Review safe work procedure (SWP) / safe work method statement (SWMS) / Job Safety Analysis (JSA)
3. Ensure cable management is addressed prior to commencing works.

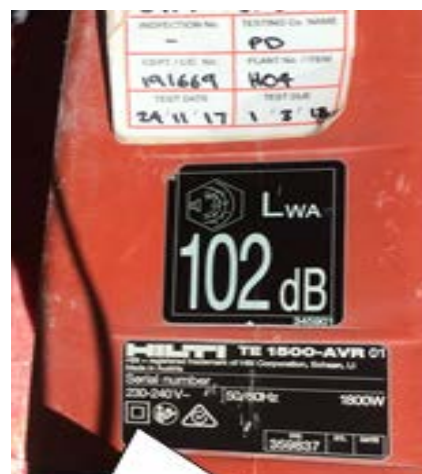
- The worker was trained, competent and inducted.
- The construction site and building mains power had RCD's in operation.
- The jackhammer was double insulated and displayed the appropriate symbol (see above), and tagged and tested.
- Cable stands were not being used at the time of the incident.
- A qualified electrician had conducted RCD inspections and testing.

Double insulation symbol
