HSEM ALERT

Pallet Racking Safety

Incident Details

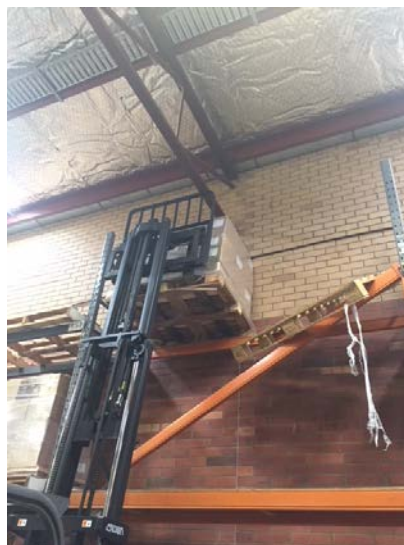
A staff member was removing a pallet from the top shelf of a racking system (5-6 meters high) with a forklift. He heard a loud noise and immediately exited the forklift truck as the front top beam of the racking system failed causing a pallet of boxes weighing approximately 630kgs to fall to the ground. No injuries were sustained.

All racking systems should be AS 4084 compliant.

All racking systems should be inspected at least once annually to confirm its integrity.

All racking inspections must be carried out by a competent person, fully experienced in the identification and categorisation of racking damage.

All areas should have a process for assessing racking systems for damage as per AS 4084. Damage to racking systems should be reported immediately to the Manager of the area.

Ensure that the working load limits are legibly displayed on each beam of the racking system. Working load limits should never be exceeded.

Bottom portions of frames exposed to possible collisions by forklifts or other moving equipment should be fitted with upright protectors and end-of-rack protectors.
